## ANTI-TIPPERS

## Maintaining Stability

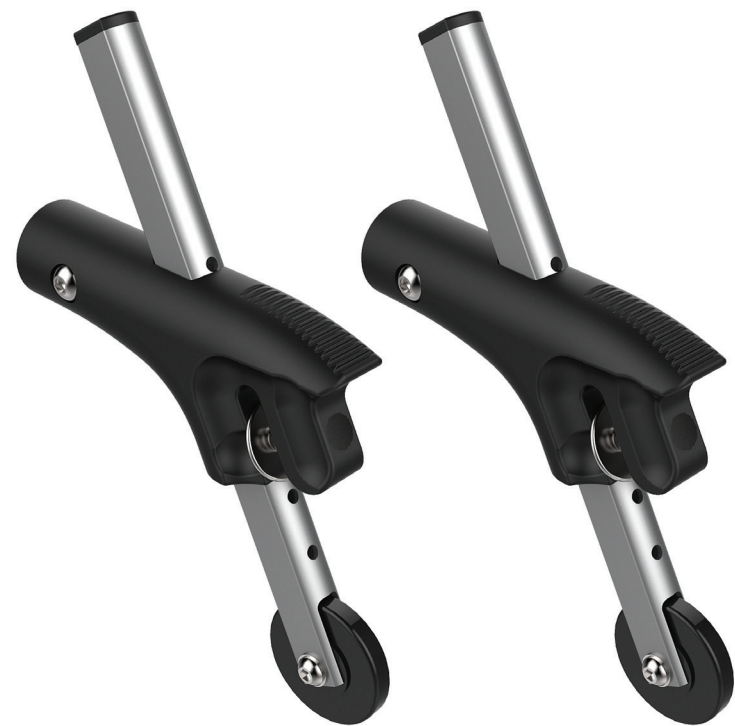
Anti-tippers are small wheels attached to the back of a wheelchair to prevent it from tipping over backward. We recommend customers use anti-tippers and always keep them extended, especially when there is not an attendant pushing the chair.

**Increased Safety:** Anti-tippers reduce the risk of the wheelchair tipping backward, which helps prevent injury.

**Better Stability:** These wheels make the wheelchair more stable, especially when going over rough ground or up steep slopes.

**Peace of Mind:** Anti-tippers give both users and caregivers confidence that the wheelchair will stay stable. This allows users to relax in their preferred position without fear of tipping over.

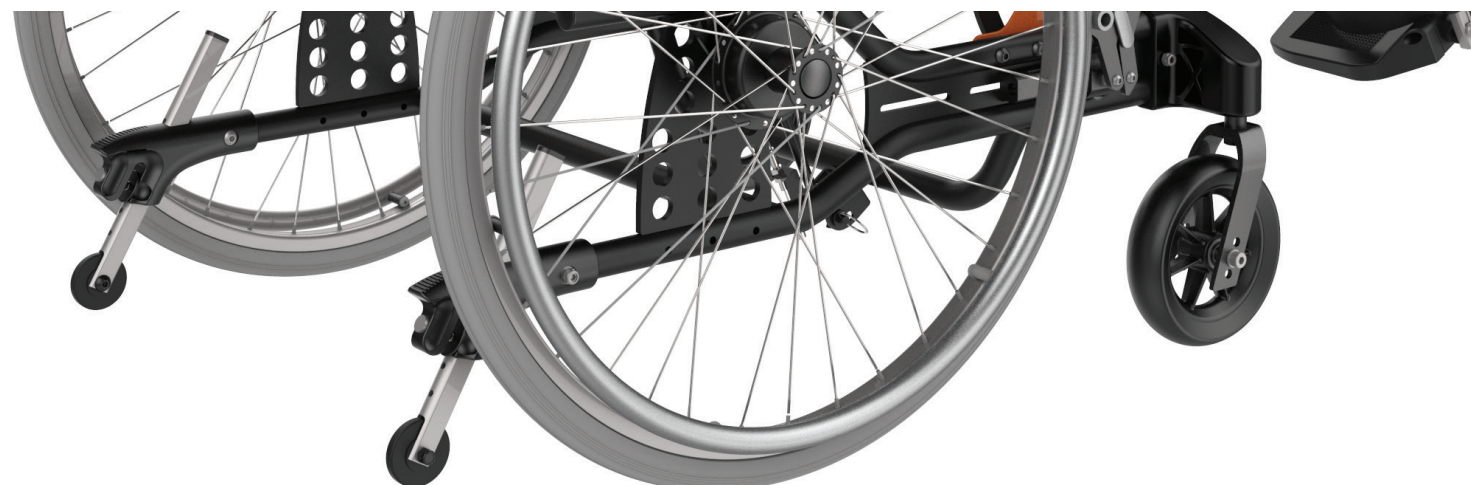
6°

**IMPORTANT!** The maximum slope/gradient for safe use of Aspire wheelchairs is 6°, this equals a rise over run ratio of 1:10. For steeper gradients, anti-tippers should be raised and a carer/attendant should stand behind the chair holding the push handles.

**Anti-Tippers work effectively up to this gradient, steeper surfaces should always be avoided.**
